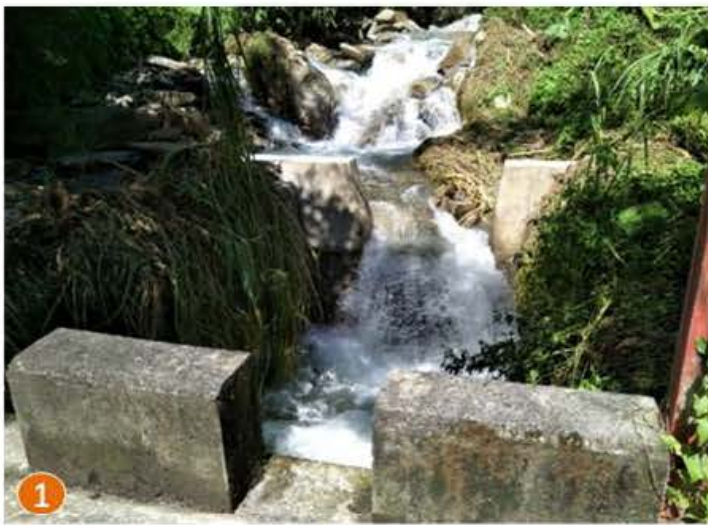
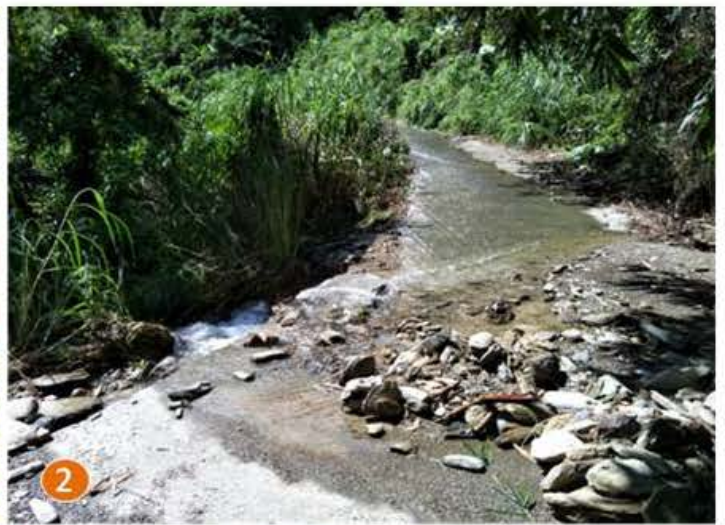
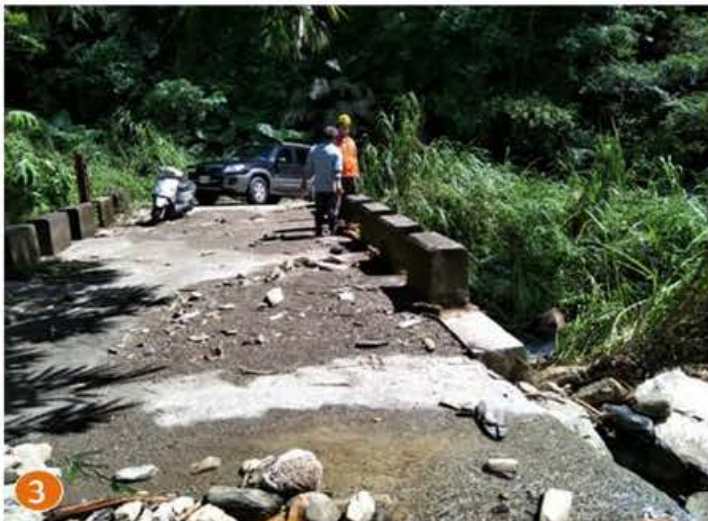
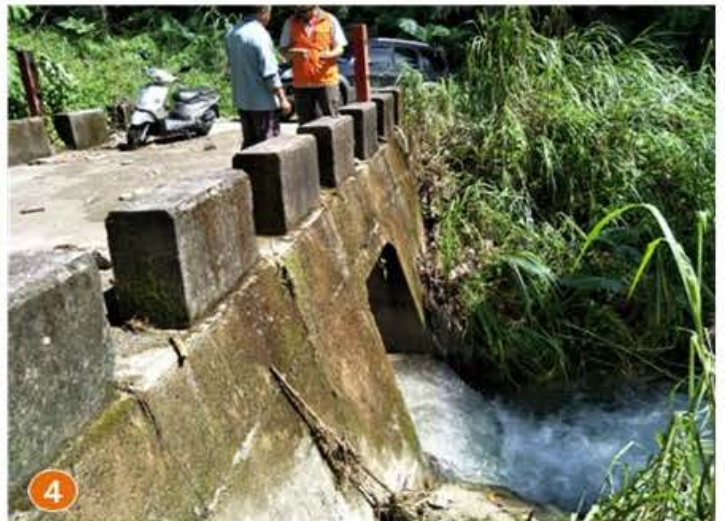
說明: B工區-106.10.16 既有箱涵通水斷面不足, 易遭受土砂雜木堵塞, 形成易致災區段
